## CIRCULATING WATER LINE INSPECTION FINDINGS

TesTex has been performing inspections on Circulating Water Lines for power plants. The inspection consists of an API 570 certified piping inspector conducting a thorough visual inspection internally and externally as access permits. Ultrasonic thickness measurements are taken where accessible.

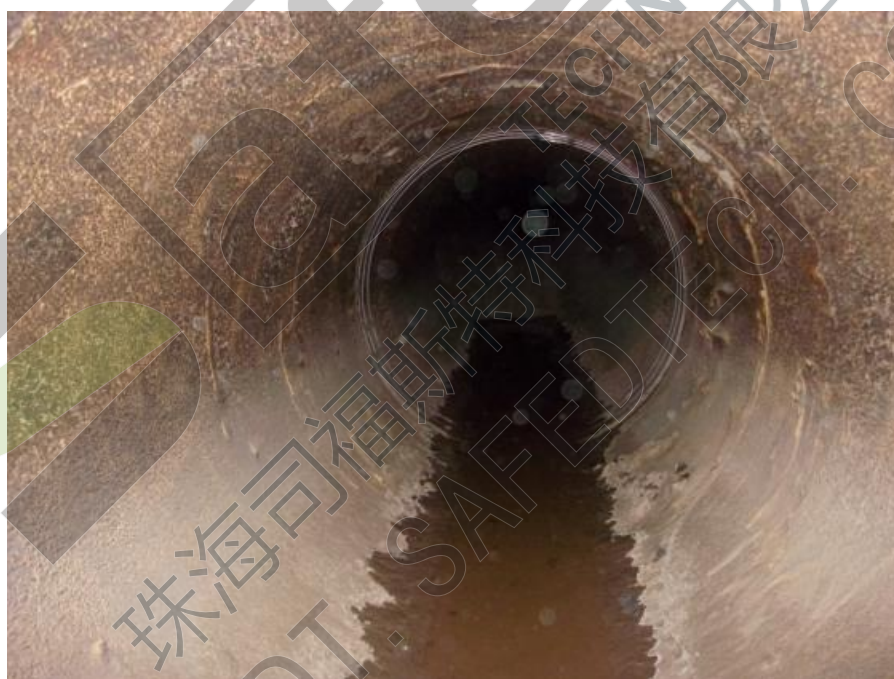
Circulating Water Line showing the concrete surface with coating in some areas

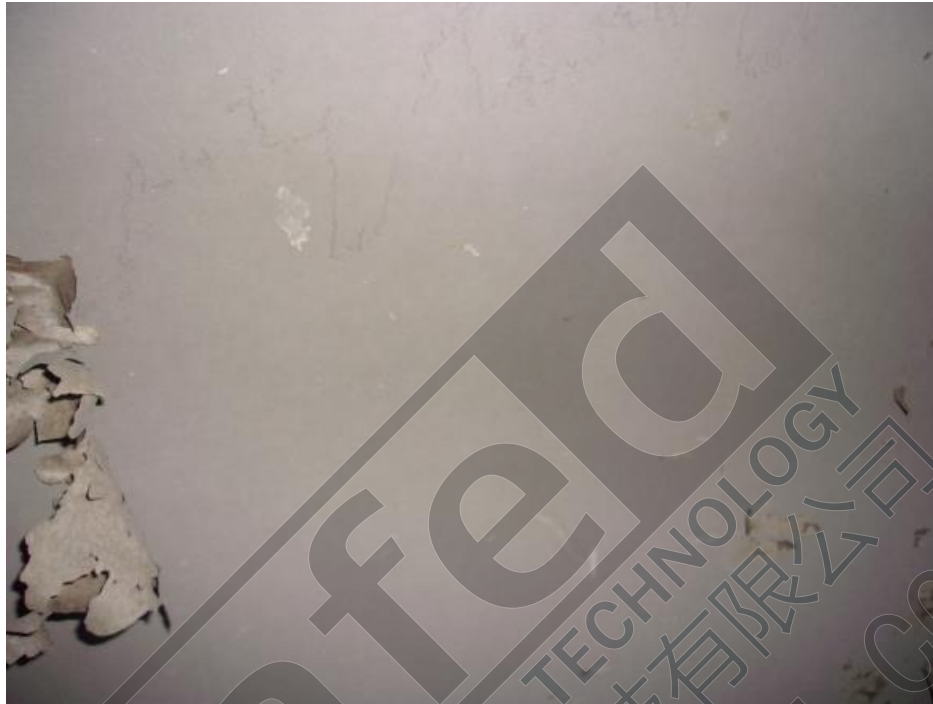
Coating on carbon steel section of pipe

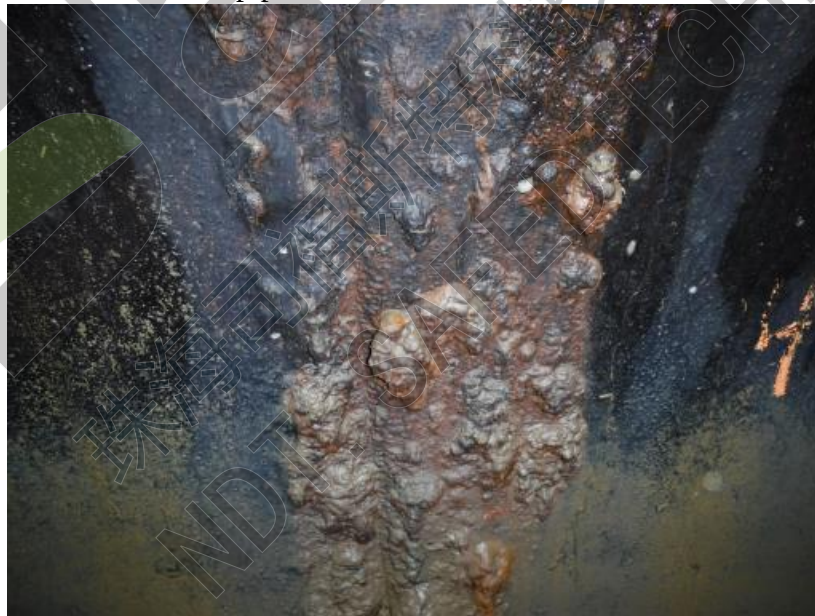
Junction of two carbon steel pipe sections where the coating has failed leading to the formation of corrosion blisters.

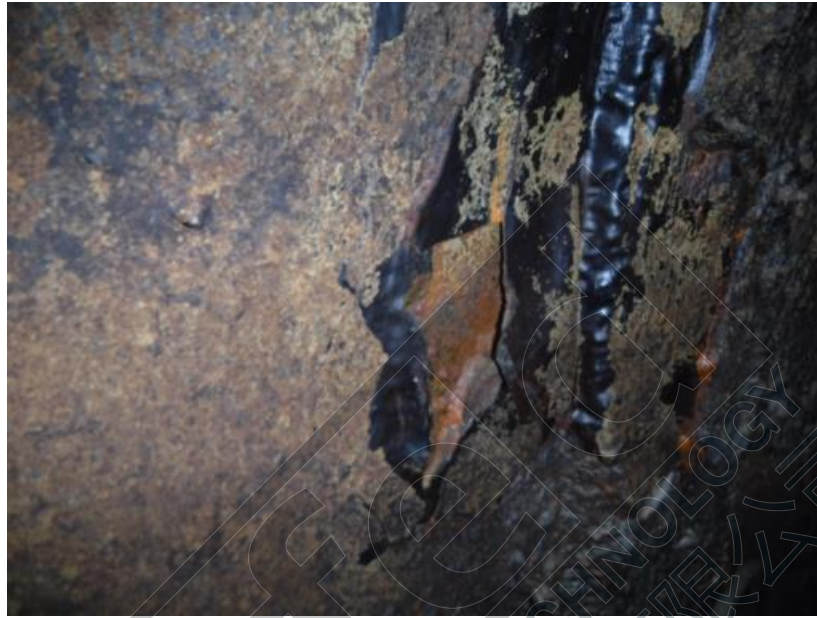
Damage to the coating of the carbon steel piping

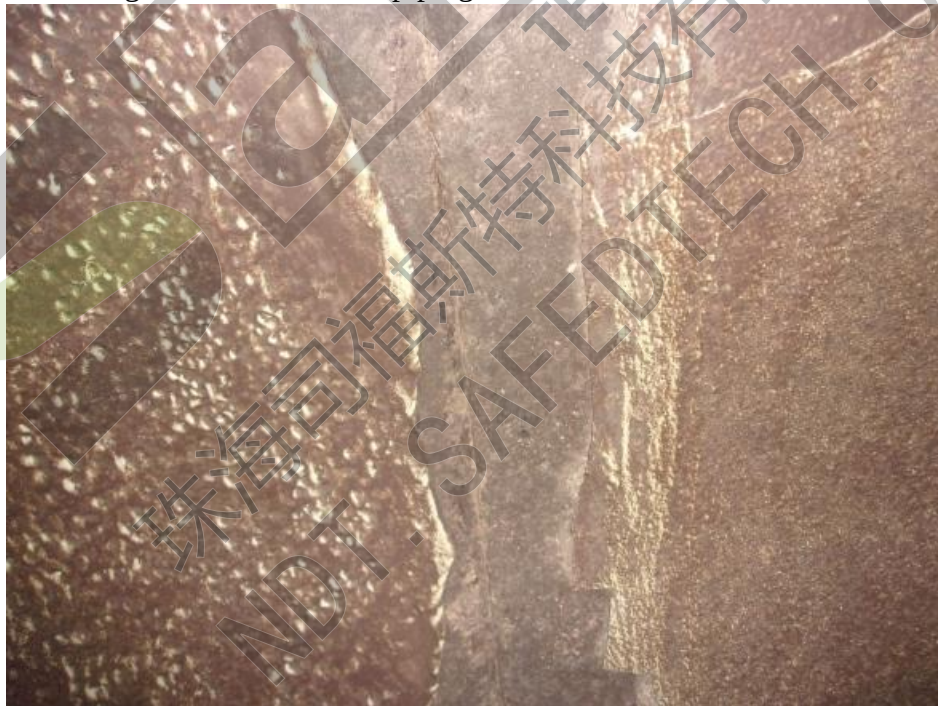
Coating Failure at a concrete joint

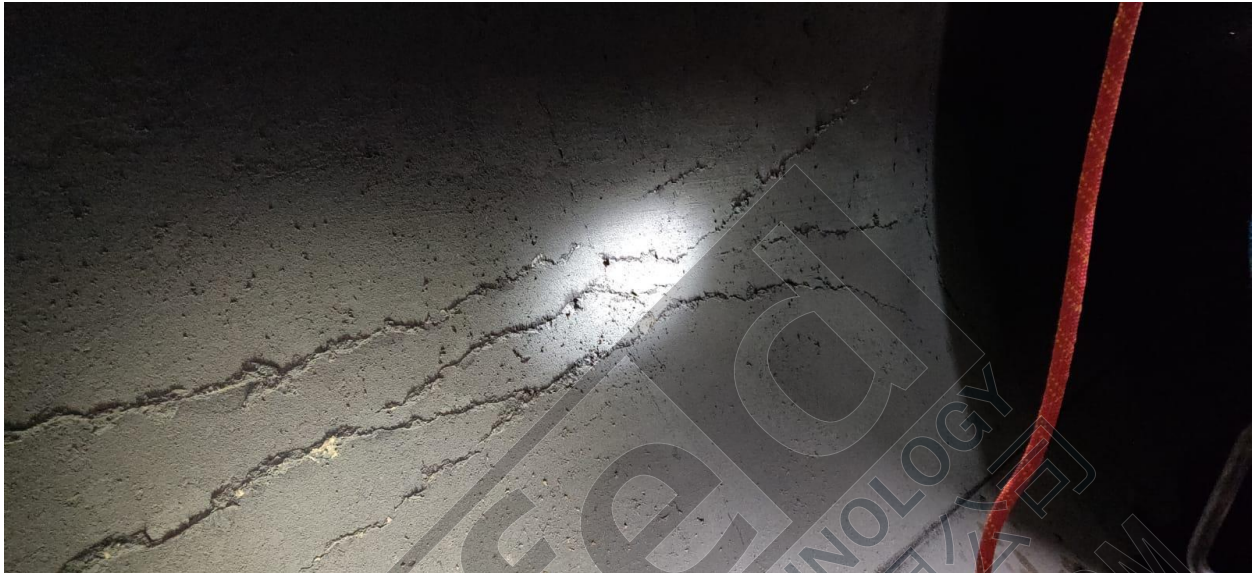
Axial Cracking on the concrete line pipe

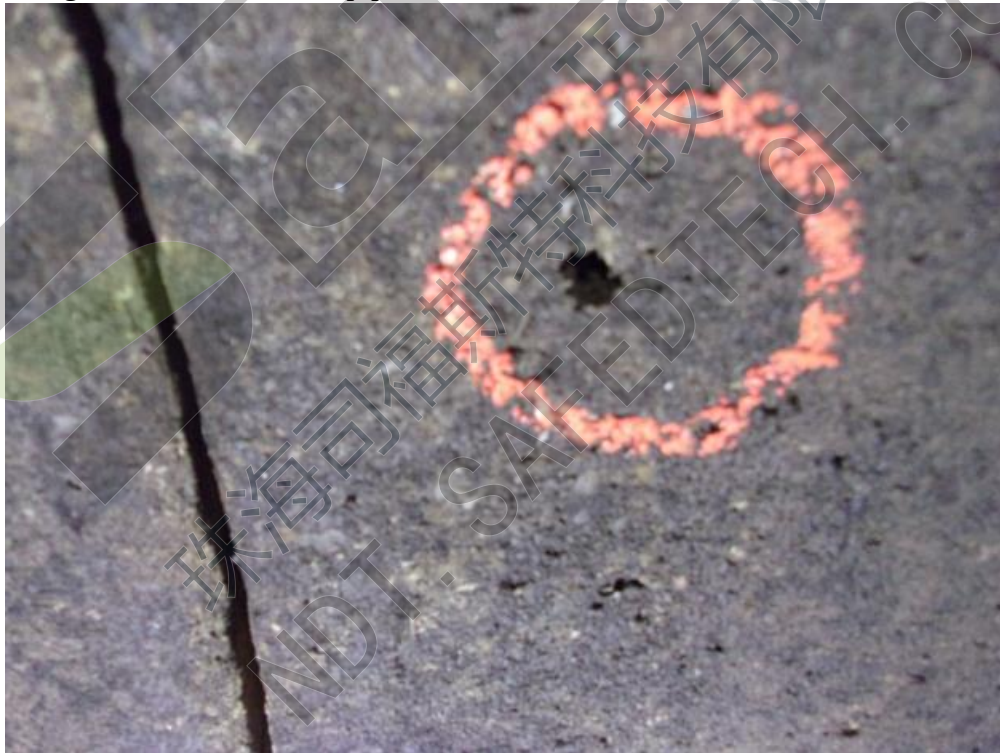
2" deep pit in concrete

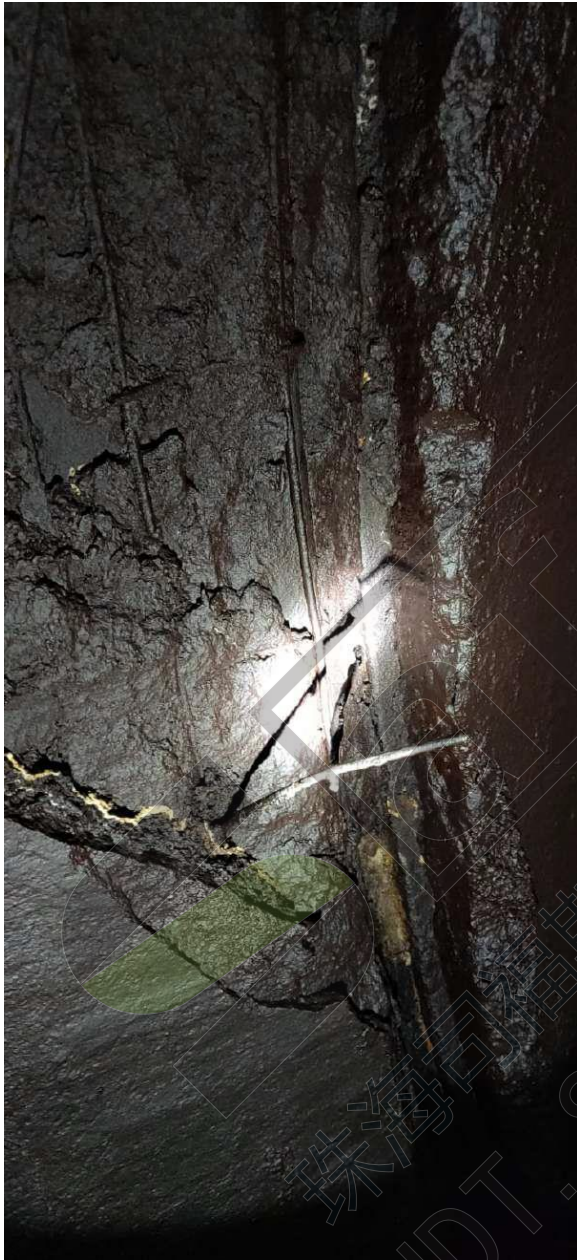
Broken prestressed wire at a bend

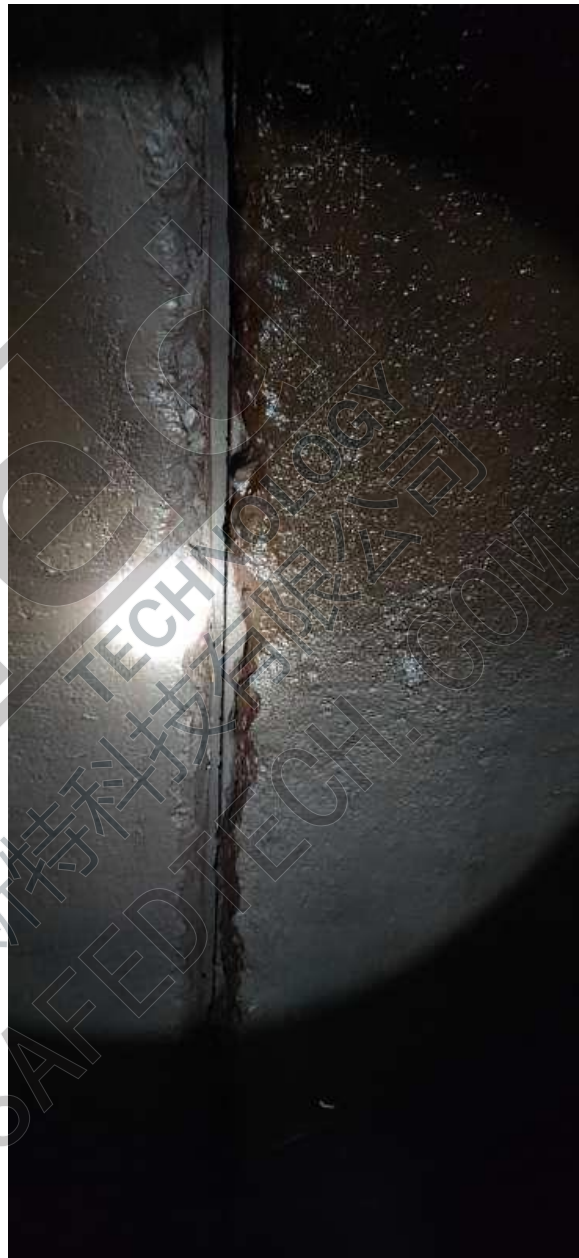
Cement Gap at a Joint

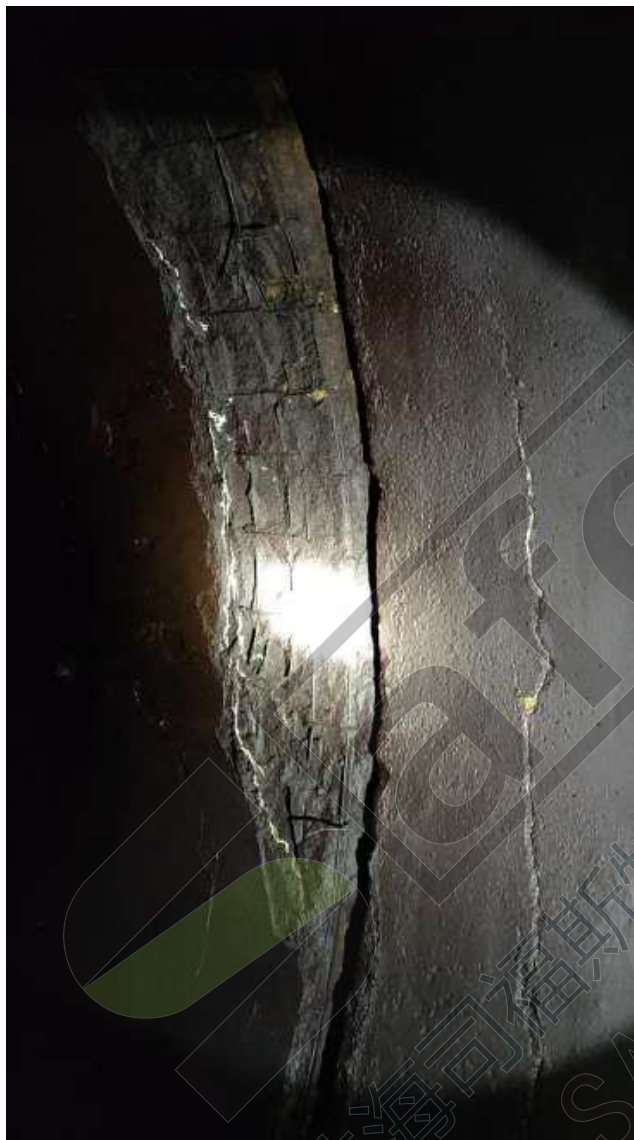
Cement Disintegration

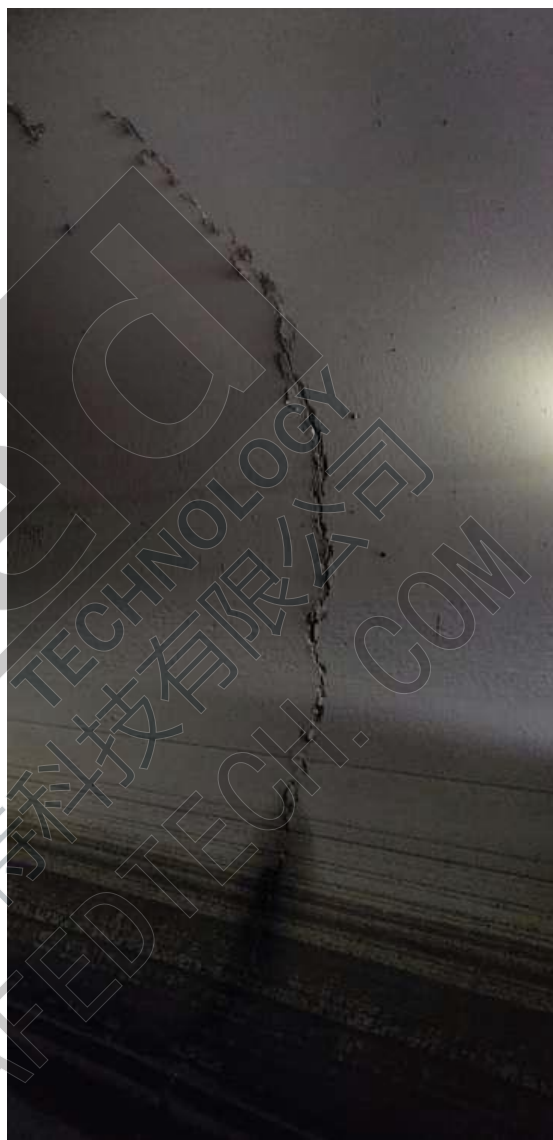
Circumferential Crack between joint 1 & 2

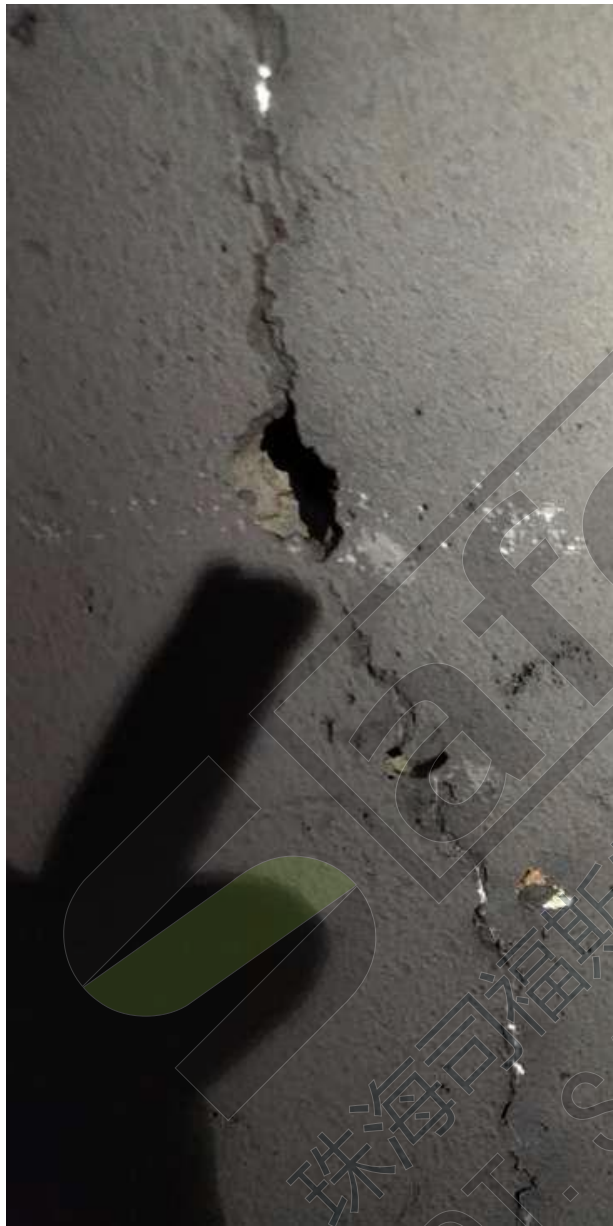
Cracking and Pitting on concrete liner

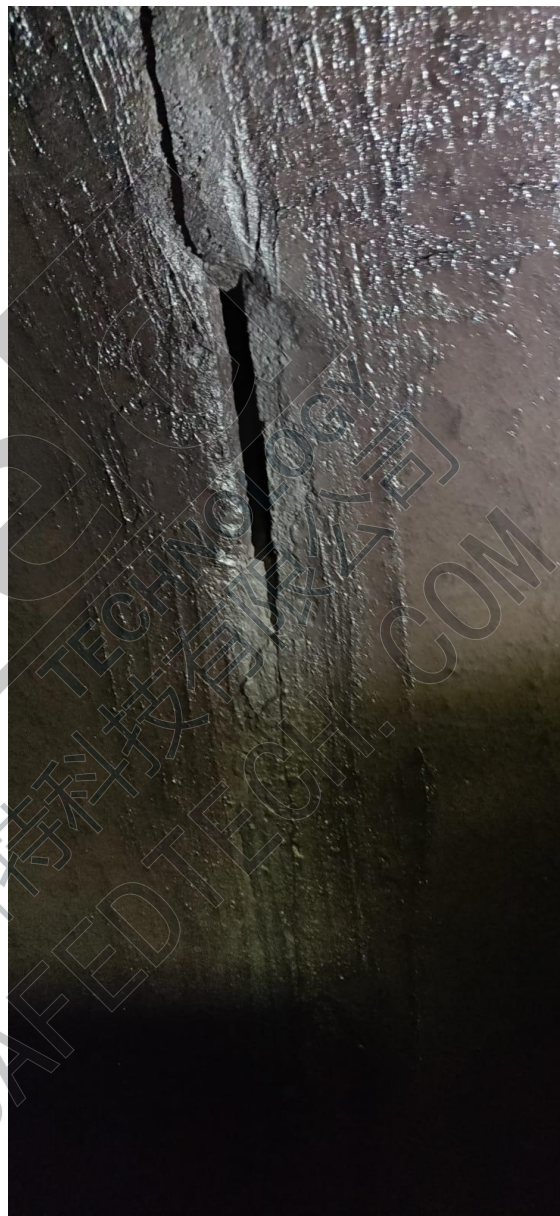
Concrete Gap at Joint

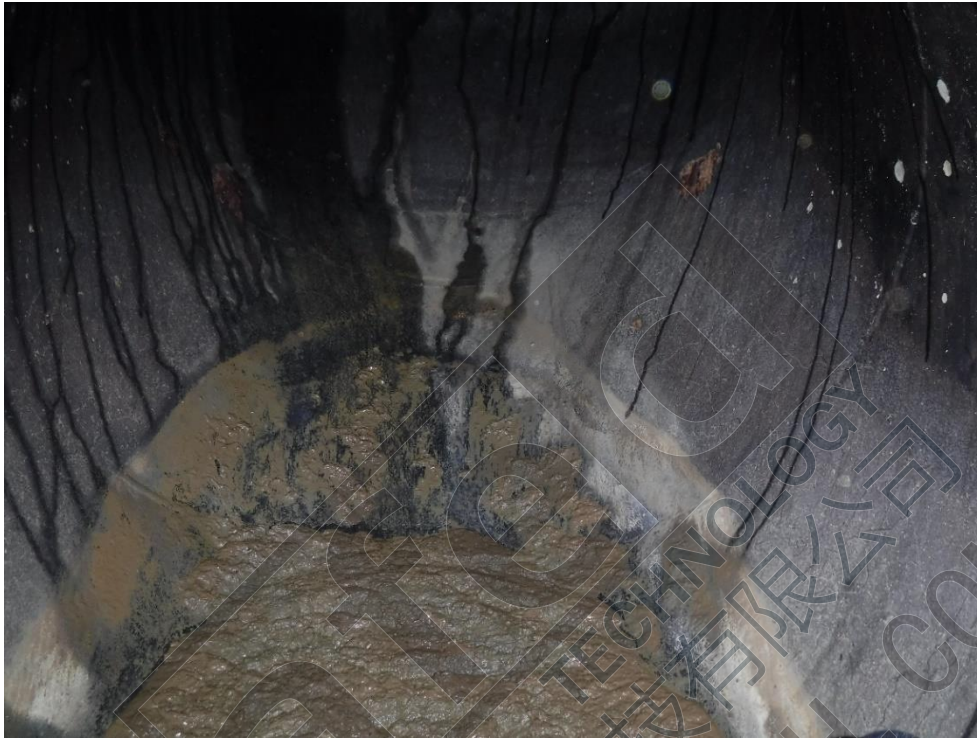
Excessive amount of mud found in Circulating Water Line.

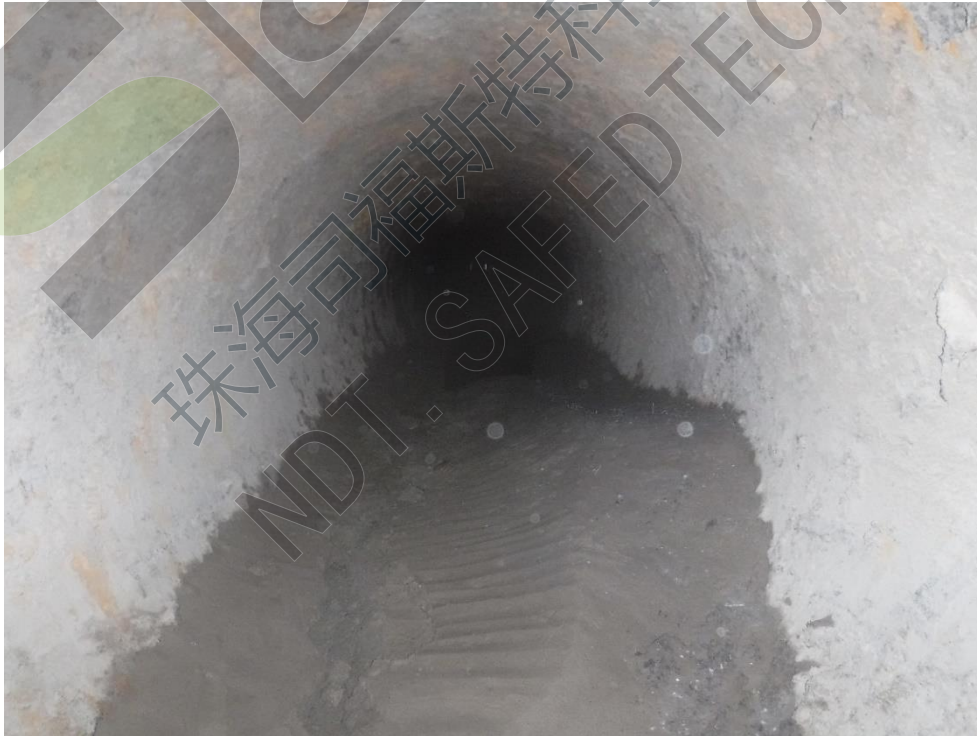
Photo shows the area with significant sediment buildup. This area is close to the condenser on the outlet side of the system.

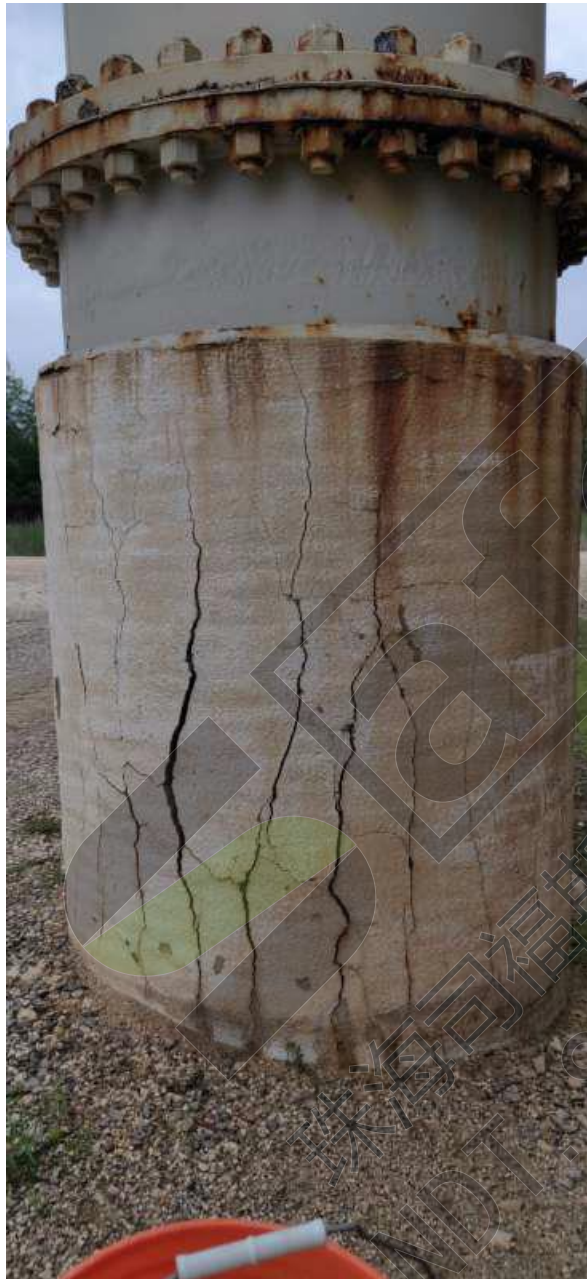
Deep Cracks in the Mortar coating on a Riser Pipe

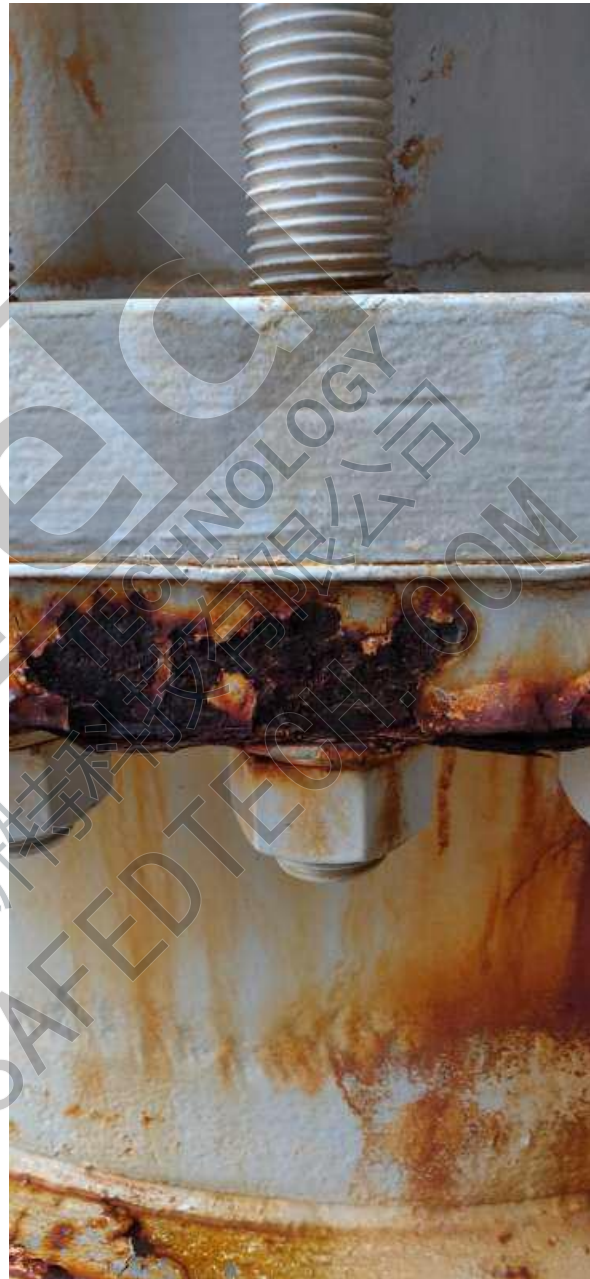
Corrosion Deterioration at flange

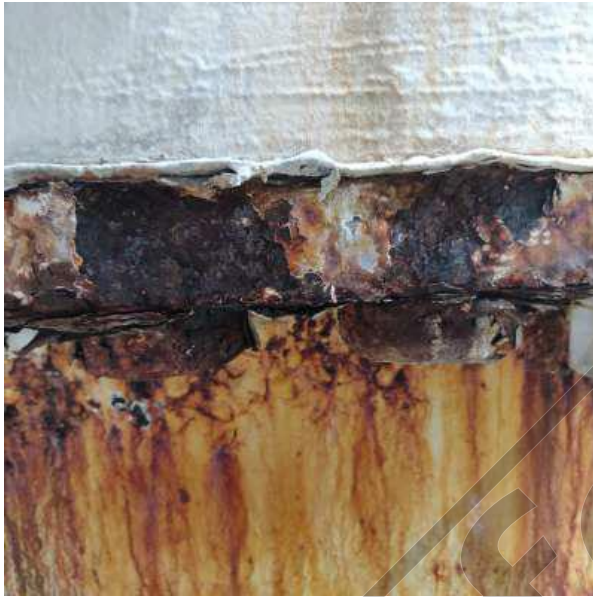
Coating Failure at a flange on the Riser Pipe

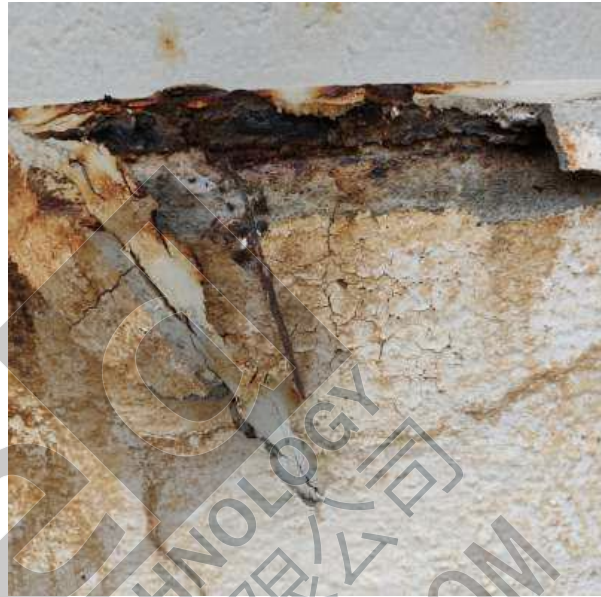
Prestressed wire exposed and broken on mortar coating of a Riser Pipe

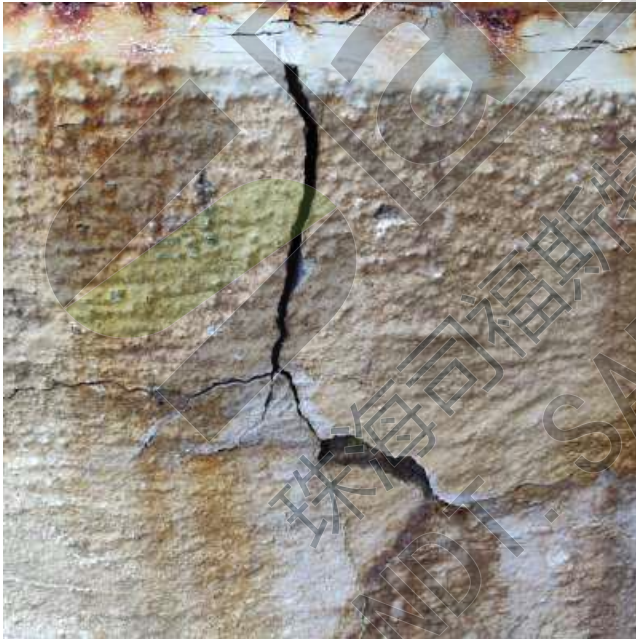
Deep Mortar Cracks on a Riser Pipe

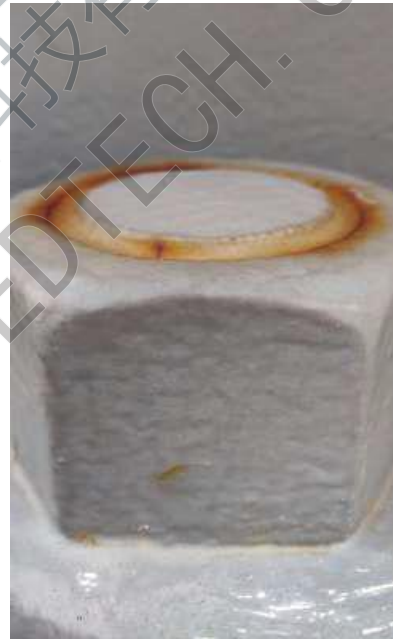
Lack of thread engagement on bolt at flange

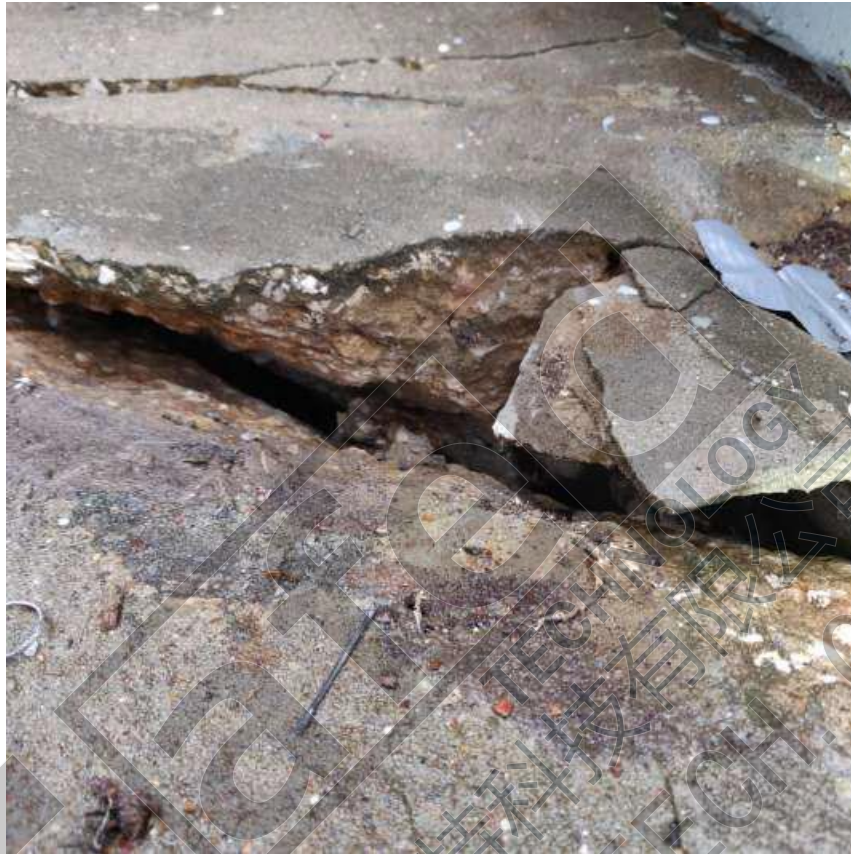
Cement base disintegration where Discharge pipe comes out of ground on Condenser side

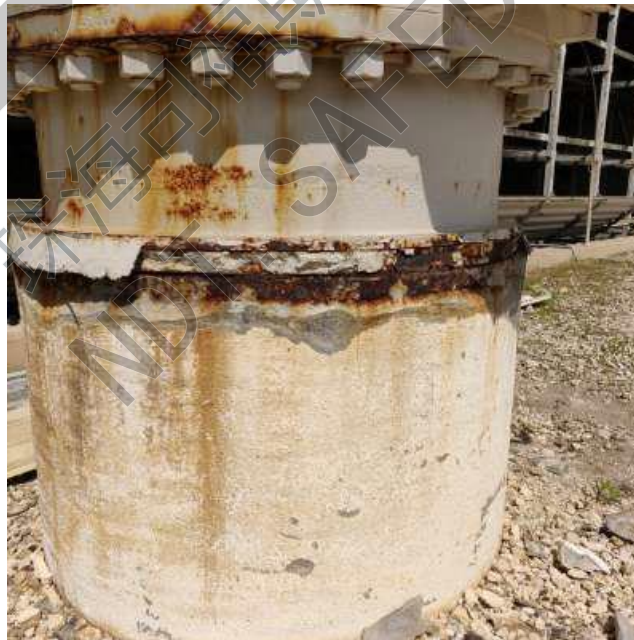
Mortar Coating failure on Riser B

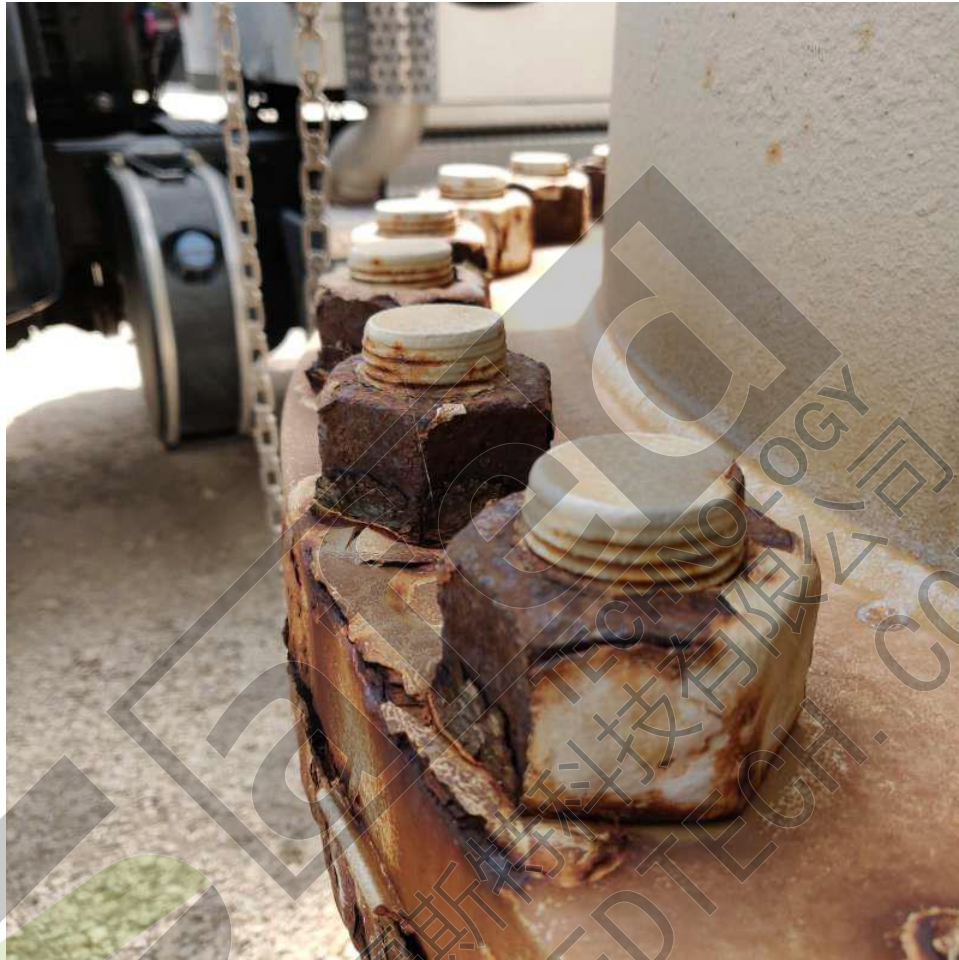
Severe bolt corrosion on flange

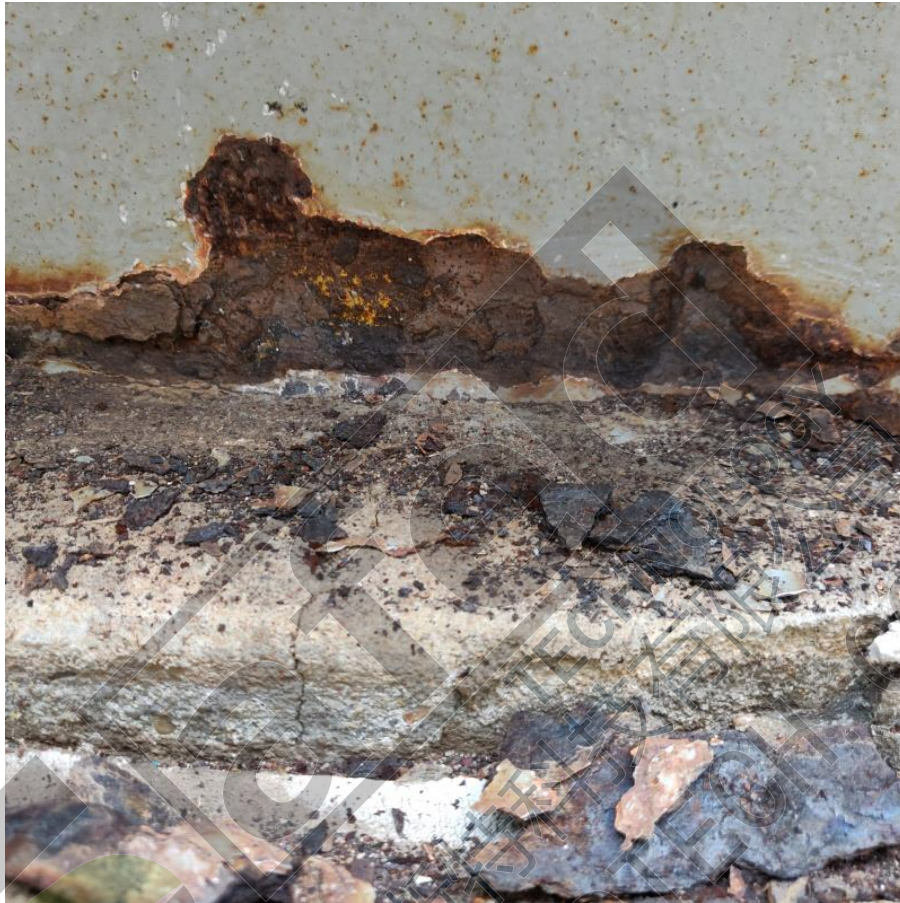
Coating Failure where Circulating Water Line comes out of the ground

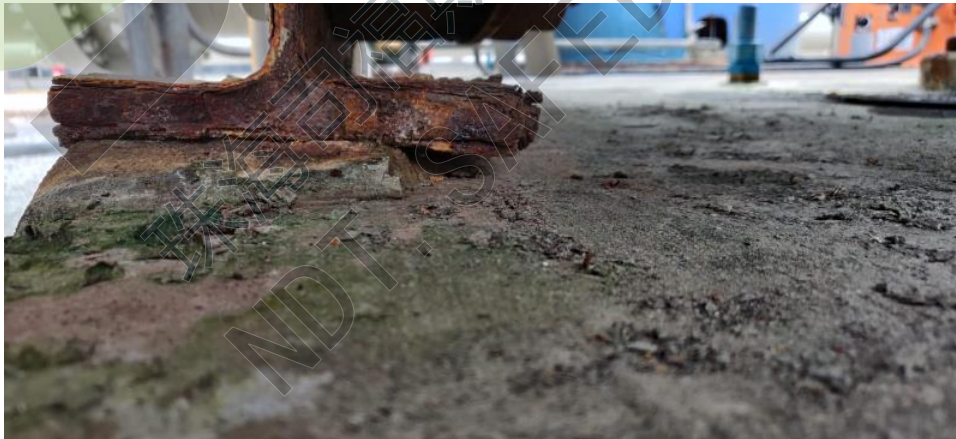
Side view of I-beam support with active corrosion

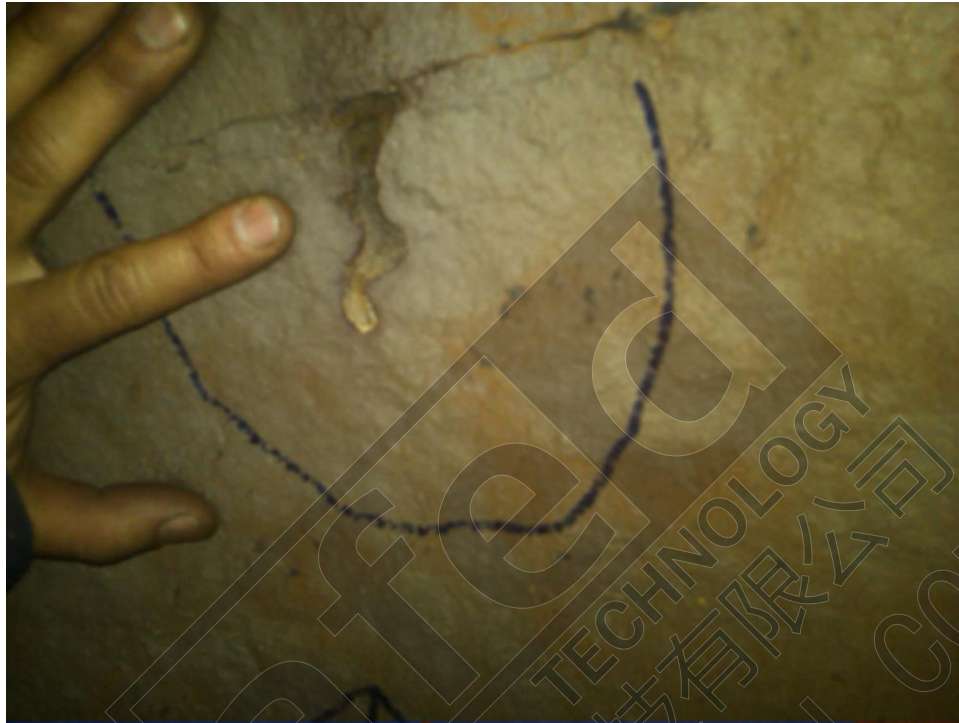
A hole found in a Circulating Water Line where it penetrates the concrete basement floor. The concrete had prevented this line from leaking.

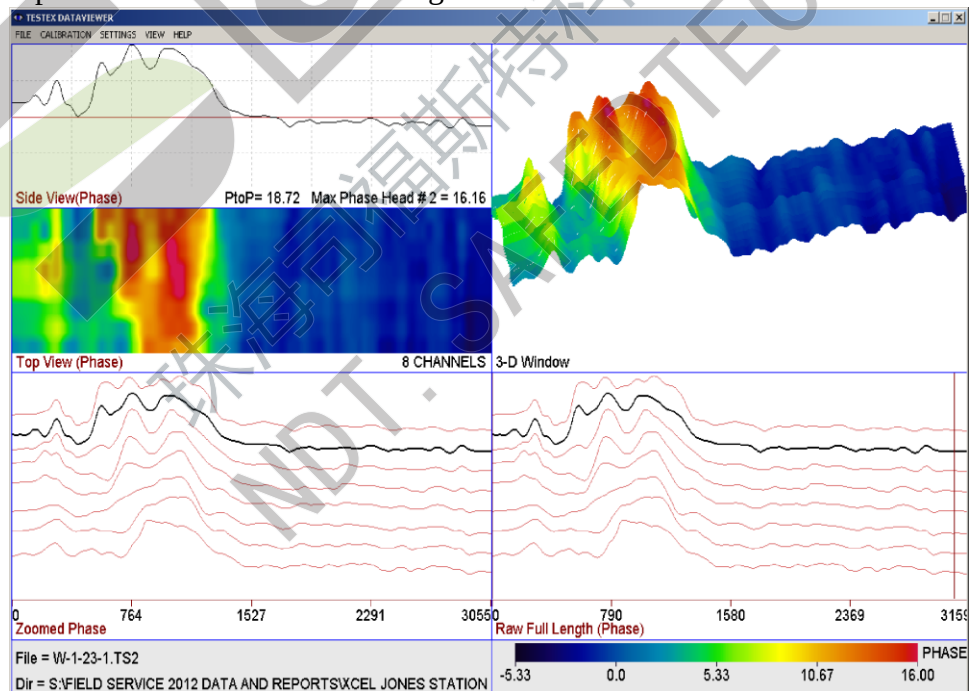
LFET waveform showing a hole in Circulating Water Line where it penetrates the concrete floor.
