# OSET – CUI Detection

Off Surface Electromagnet Technology  
离面电磁检测技术 - 保温层下腐蚀检测

# Corrosion Under Insulation Detection System

保温层下的  
管道腐蚀检测系统

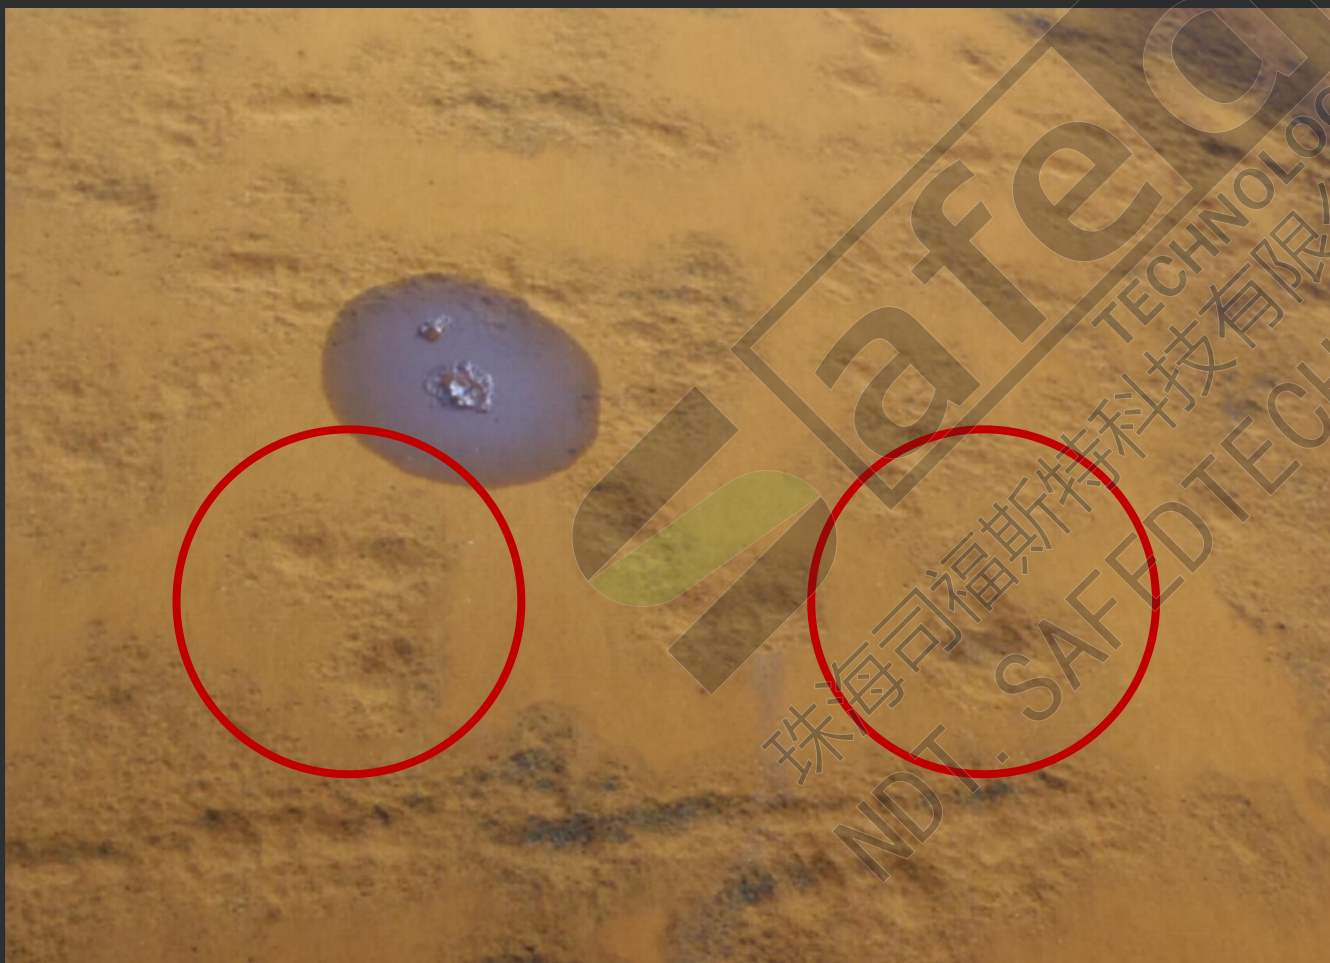
## High Pressure Vessels 高压容器平板

Tests to detect CUI on insulated vessels and tanks. These first tests were designed to find areas of isolated wall loss as shown in the

picture  
检测隔热容器与储罐上的CUI。验证测试的目的为扫描到独立的壁损区域，如图片所示。

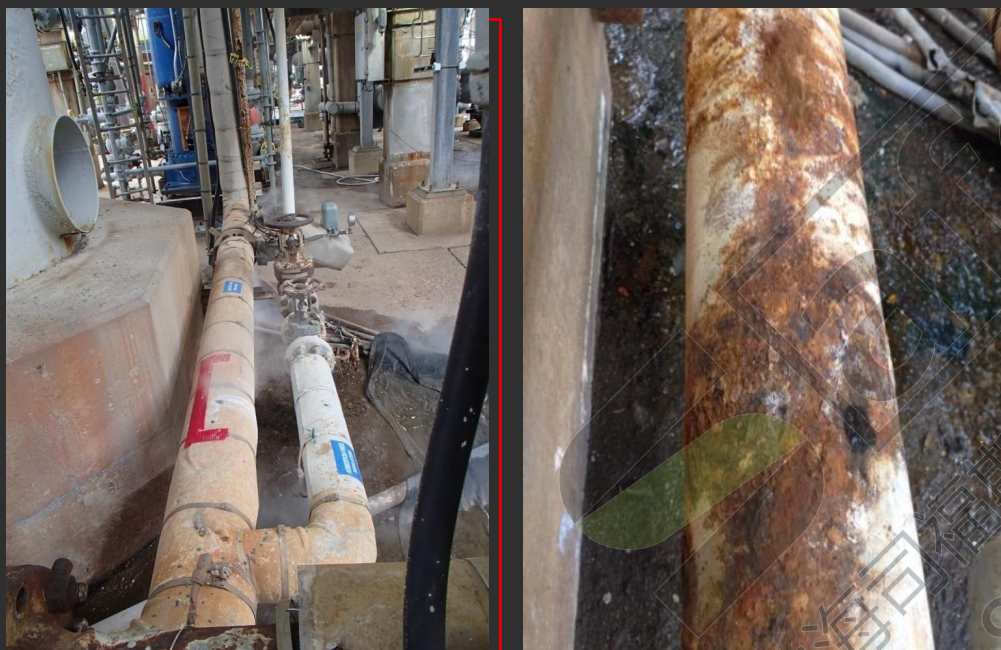
- Pictures of a 4" pipe with suspected corrosion before & after the jacketing was removed.
- 图片展示了一条炼油厂4 英寸管道，左边为移除护套前，右边为移除护套后。
