# Trending non-linear wall loss of petrochemical vessel

In-service, high-temperature corrosion monitoring of a critical vessel on a petrochemical plant

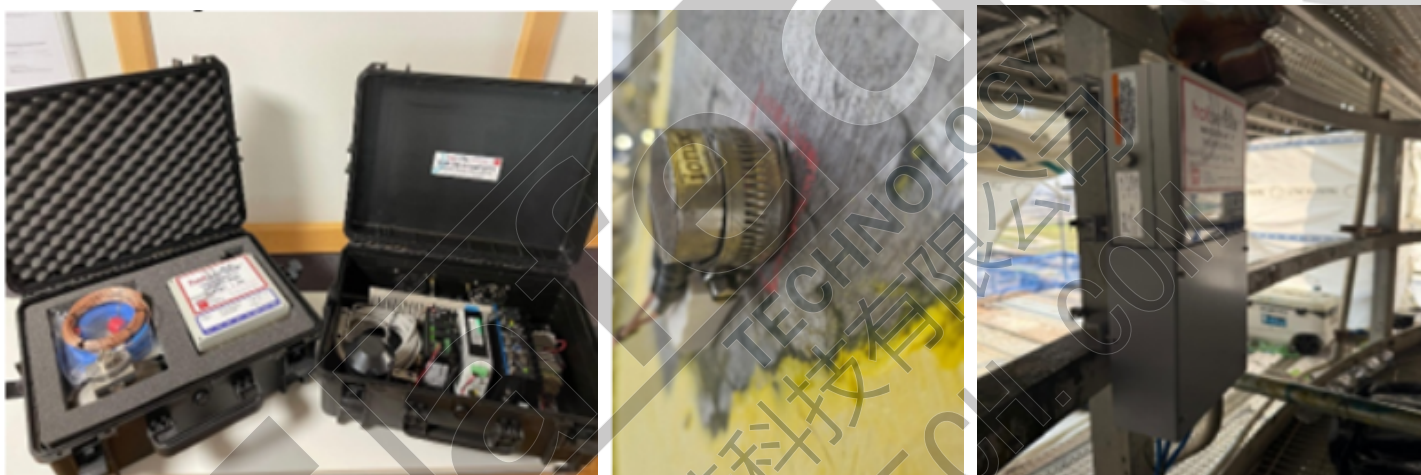
- HotSense DE sensors with an epoxy coupling solution were selected to withstand continuous operation up to 350°F while providing stable and reliable thickness measurements.
- The HotSense DE sensors were modified with additional mechanical support to ensure long-term reliability, as the installation location is inaccessible once deployed.
- Four CALIPERAY WirelessHART monitoring nodes were installed, each connected to three probes and equipped with an individual thermocouple to enable accurate temperature compensation.
- A HotSense Field Deployment Kit was deployed on site, consisting of a WirelessHART gateway and an industrial edge PC running the WAMP server to securely collect all monitoring data locally.
- A secure remote connection to the WAMP server was established, enabling off-site review, analysis, and export of monitoring data.

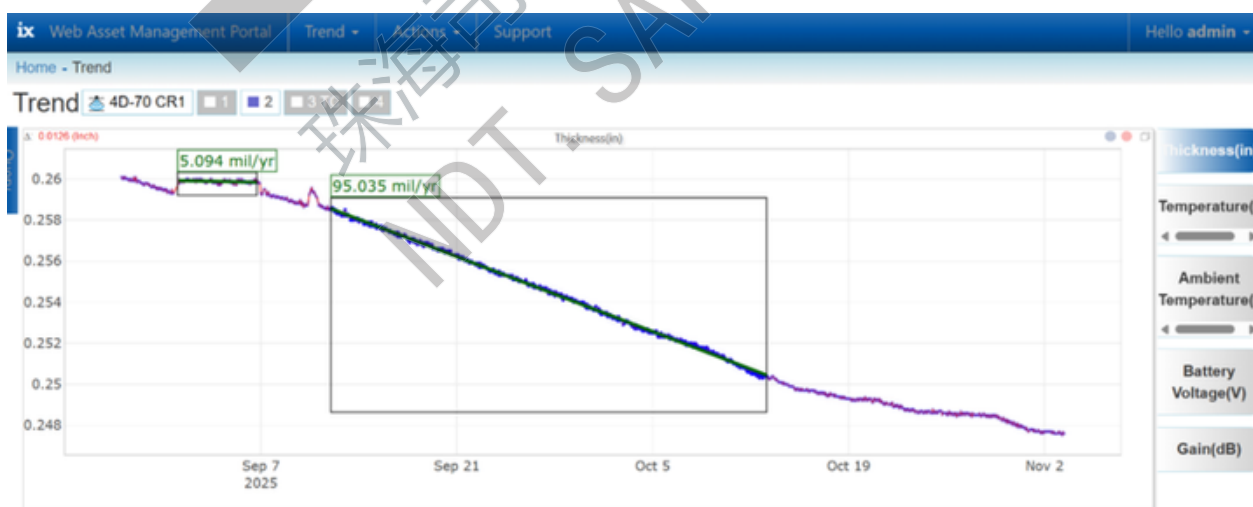
The full system solution was successfully deployed in 2 days during live plant operation, together with a full WirelessHART network system. System software has been installed, and data was made available at all the required control centres feeding the client's Plant Integrity Monitoring Systems.

Using HotSense™ installed with CALIPERAY monitoring nodes allowed for **automated, robust and reliable wall thickness measurements to be collected from live high temperature assets.**
