# Energy From Waste Wall Loss Monitoring

In-service, high-temperature, high-precision corrosion monitoring of critical assets in UK Energy Recovery Facility (ERF).

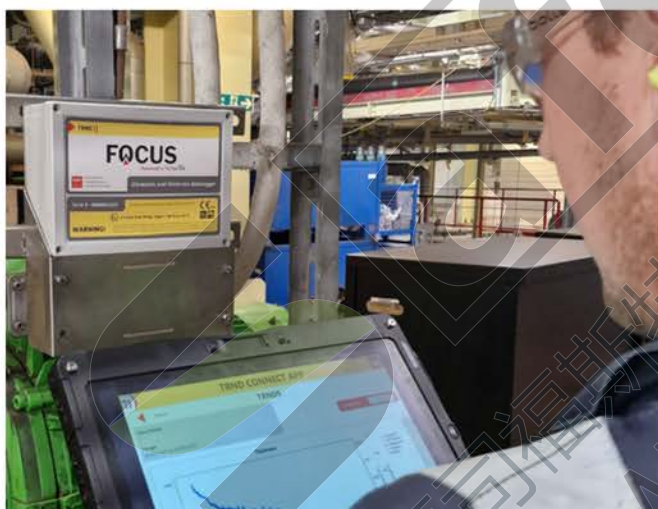
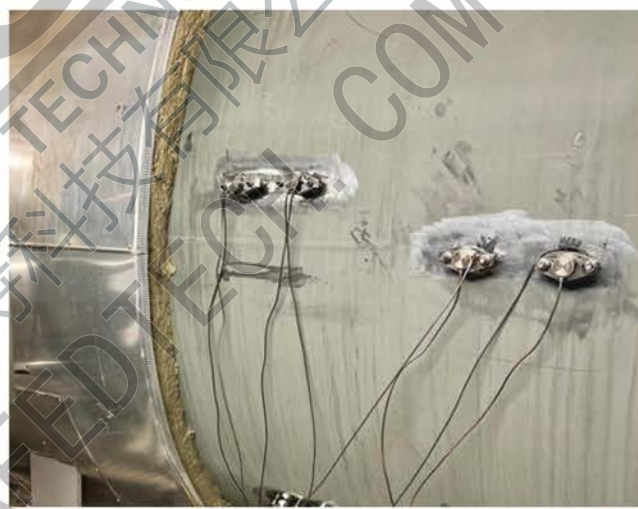
- Fixed-point HotSense™ 380 sensors with a solid couplant were chosen to survive the conditions and deliver stable, reliable thickness measurements, with a detectable wall loss of  $\pm 0.025$  mm.
- The welded-stud deployment system was used to mount sensors at the thickness monitoring locations across each large-diameter vessel.
- The HotSense™ sensors were connected to TRND Measurement Hubs, allowing quick, simple readings from easy-to-access connection points to get started before upgrading to a wireless solution. Data from the hubs were collected and verified using a commercially available thickness gauge.
- The system was deployed, and measurements were collected by the incumbent NDT service provider, Apave UK, who provided traceability and compliance to relevant procedures while expanding their service offering with the technology.

- Apave UK deployed the solution during a short shutdown of under 49 hours.
- 16 sensors with thermocouples for accurate temperature compensation were installed under the insulation, together with TRND Measurement Hubs.
- Since installation, stable and repeatable measurements have been collected, with temperature compensation applied by the gauge.
- Wall-thickness data is now collected frequently by inspection technicians while the plant is on-stream, ahead of an upgrade to an autonomous wireless solution.
