## CIRCULATING WATER LINE INSPECTION FINDINGS

TesTex has been performing inspections on Circulating Water Lines for power plants. The inspection consists of an API 570 certified piping inspector conducting a thorough visual inspection internally and externally as access permits. Ultrasonic thickness measurements are taken where accessible.

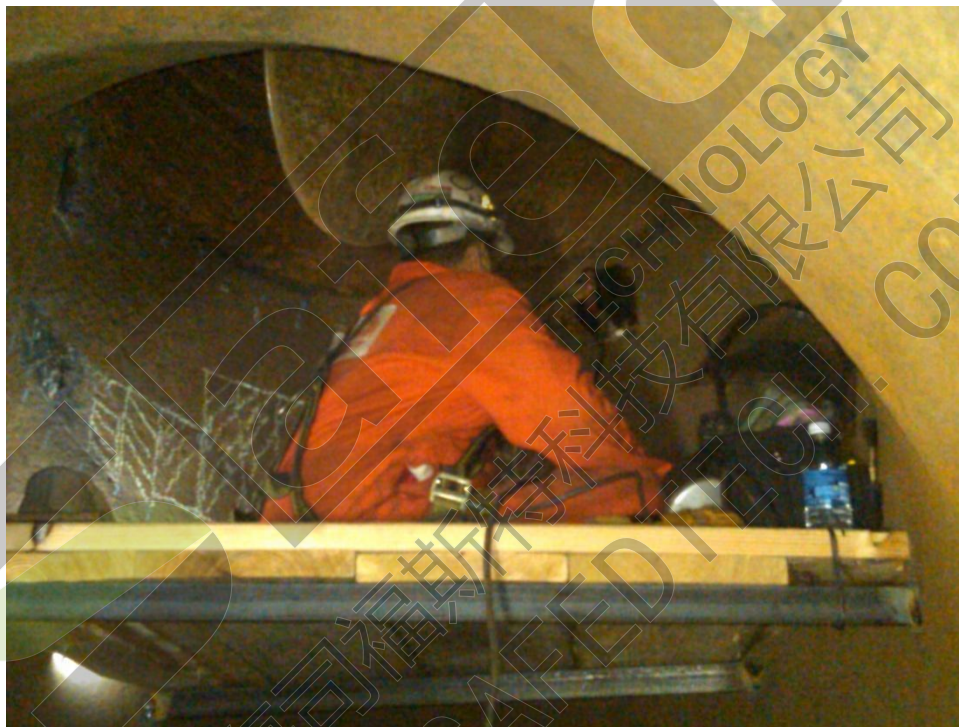
The picture above shows a technician scanning the Circulating Water Line where it penetrates the concrete basement floor.
