# Erosion Monitoring of Buried Tailing Lines

In-service, erosion monitoring of buried pipeline infrastructure of a mining operation

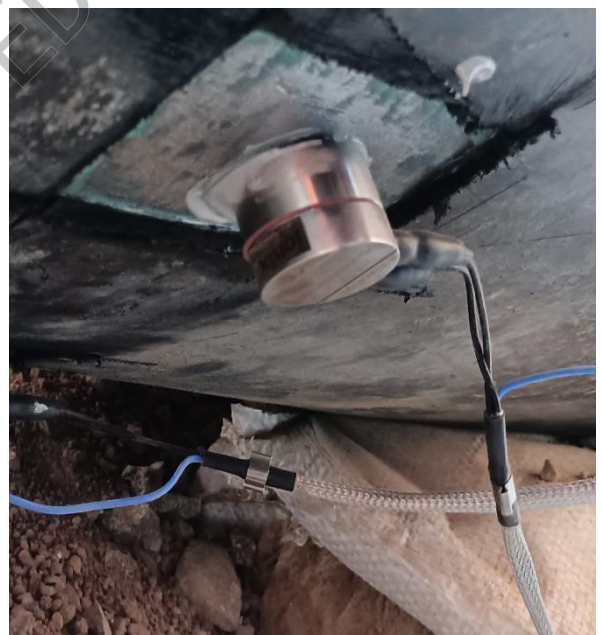
- Monitoring of erosion events was required to link to process events up-stream to enact preventative measures and schedule repair.
- The expense in exposing and inspecting the buried sections of the tailing lines meant that traditional, hands-on inspection solutions were not viable.
- Robust sensors were required to be buried and accessed manually by survey teams, without the need to expose the tailing lines themselves.

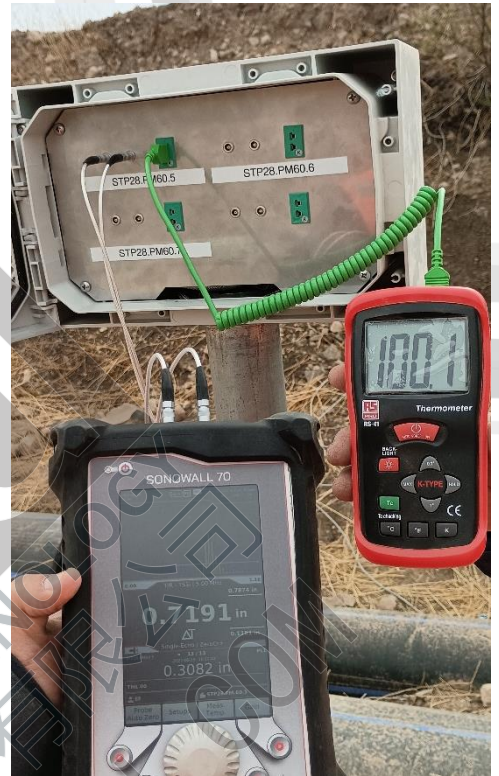
- 38 HotSense™ DE sensors were installed using integrated high-strength magnetic fixings, along with epoxy coupling, for a robust and low-profile deployment.
- HotSense™ DE sensors were chosen due to their low-cost, high-accuracy and precision measurements to allow for reliable erosion trending.
- HotSense™ sensors were paired with Ionix Measurement Hubs at ~100m intervals to allow quick and simple measurements to be collected from easy-to-access connection points. The data from the Measurement Hubs was collected using commercially available thickness gauges.
- The sensors were composite wrapped for added protection and electrical isolation from the ground.

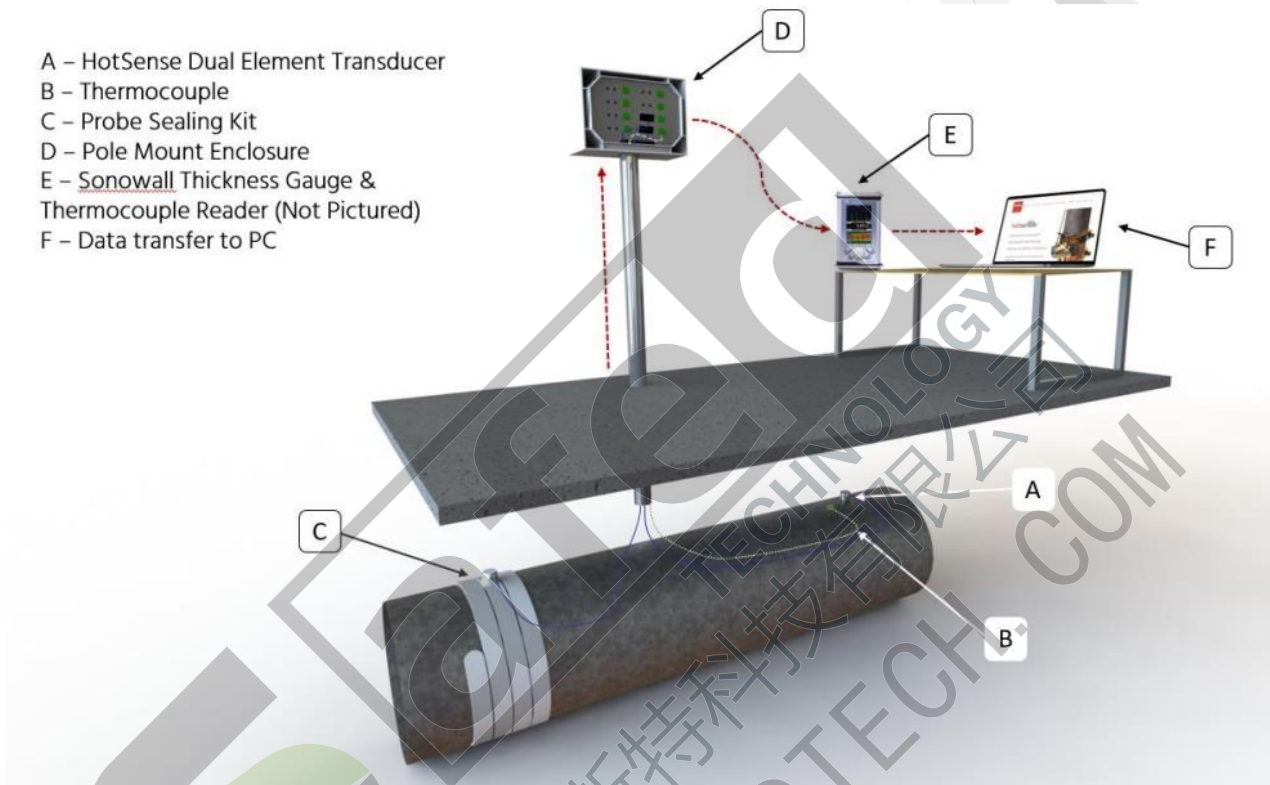
A – HotSense Dual Element Transducer  
B – Thermocouple  
C – Probe Sealing Kit  
D – Pole Mount Enclosure  
E – Sonowall Thickness Gauge & Thermocouple Reader (Not Pictured)  
F – Data transfer to PC

- The system solution was successfully deployed during a small excavation period, comprising 38 sensors across several kilometres of piping.
- The Measurement Hub is conveniently positioned on a 2-inch raised pole, up to 15m from the sensors. All cabling from the sensors and thermocouples will be routed through the raised pole and are terminated in the measurement hub enclosure. This is a simple and cost-effective means of acquiring measurement data therefore reducing time on site and therefore costs.
- By implementing our solution, clients can gather dependable and consistent data to support erosion management programs and risk-based inspection (RBI) while assets remain in service, eliminating the need for excavations. This approach enhances productivity, improves operational safety, and reduces operating costs.
